**TUOLUMNE COUNTY  
GRAND JURY  
12855 Justice Center Drive  
Sonora CA, 95370**

**Tuolumne County 911:  
Sheriff's Dispatch Center Report  
May 31, 2024**

**Tuolumne County Justice Building, 28 N. Lower Sunset Dr., Sonora, CA**

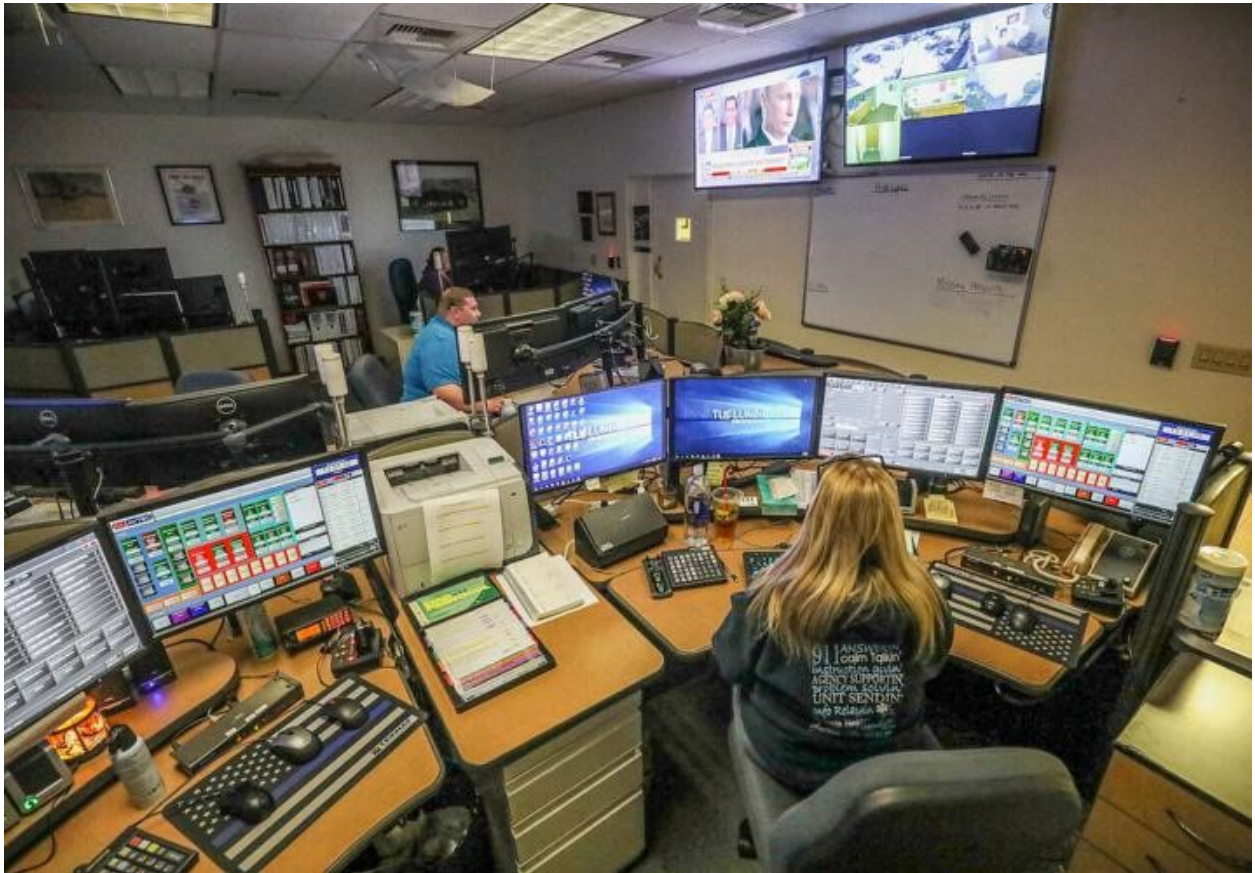
## APPENDIX B

In terms of the environment, the dispatch center lacks working conditions conducive for 911 dispatchers. Currently, there are workspaces for 6 dispatchers. Each workspace is roughly six feet by six feet (Appendix B). The dispatch work room does not have any windows; therefore, there is no natural light for the employees working long 12-hour shifts. This is particularly concerning in the winter months when dispatchers might not see sunlight during their workdays. Various studies show that exposing workers to only artificial lighting puts their physical and mental health in danger. A 2015 study published in *Chronobiology International* concludes that lack of exposure to natural light at work is related with high levels of cortisol and low levels of melatonin at night, which is itself related to depressive symptoms and a poorer quality of life.<sup>14</sup>

**R2.** The Grand Jury recommends that Tuolumne County Administration creates a more conducive working environment to attract and retain sheriff dispatchers including a more functional and safer dispatch workroom, a suitable breakroom, and a more acceptable restroom for the 20 dispatch center employees. (F1, F2)

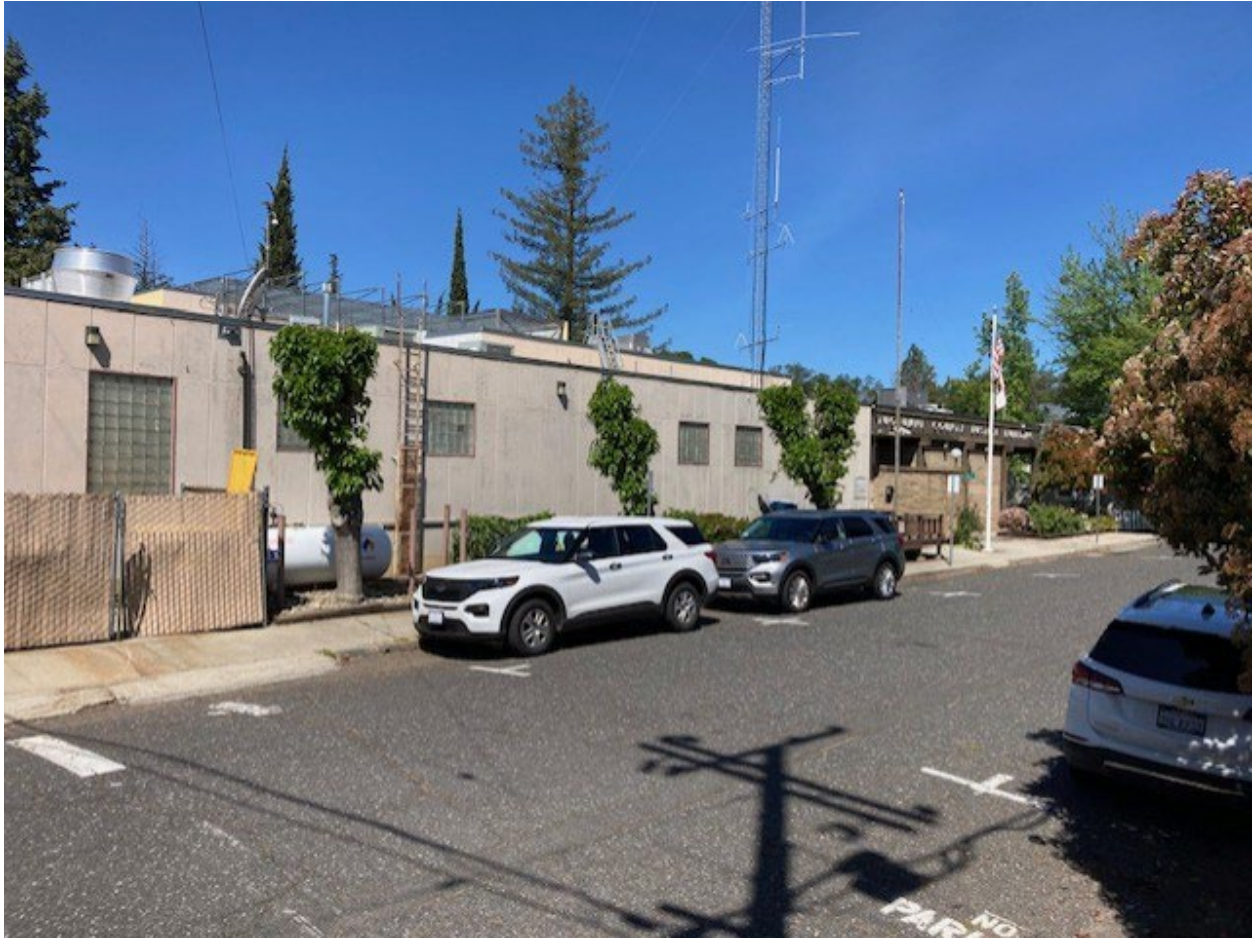
## APPENDIX C

It is important to note that an unused section of the old jail adjacent to the sheriff's administration consists of over 5,000 square feet of concrete and steel structure that could be converted into additional space for the Tuolumne Sheriff Justice Center. A renovation of the Tuolumne County Sheriff Justice Center and the unused jail—premises currently owned by the county--would be more cost effective than building a new facility. Furthermore, the sheriff patrol, investigations, professional standards, and evidence and property offices could be moved out of rented space and into the Lower Sunset building. (Appendix C)

28 N Lower Sunset Dr., Sonora, CA. Unused section of Tuolumne County Justice Center

**R1.** The Grand Jury recommends that Tuolumne County Administration and the Board of Supervisors identify sources of funding to either locate an alternative site for the Sheriff's Dispatch Center or renovate the Tuolumne County Sheriff Justice Center to meet current and future needs. (F1)
